Report of Dam Safety Assessment
of Coal Combustion Surface Impoundments
Interstate Power and Light Company
Sutherland Generating Station
Marshalltown, IA

AMEC Project No. 3-2106-0191

October 2012

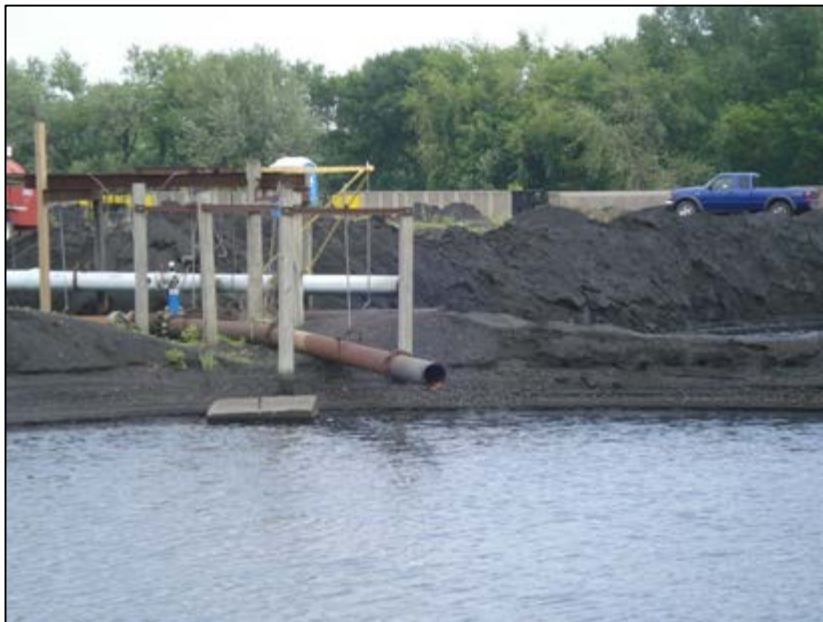
SP-1
LOOKING NORTH AT CCW INLET PIPE TO SOUTH POND.
NORTH POND ABOVE AND TO THE RIGHT

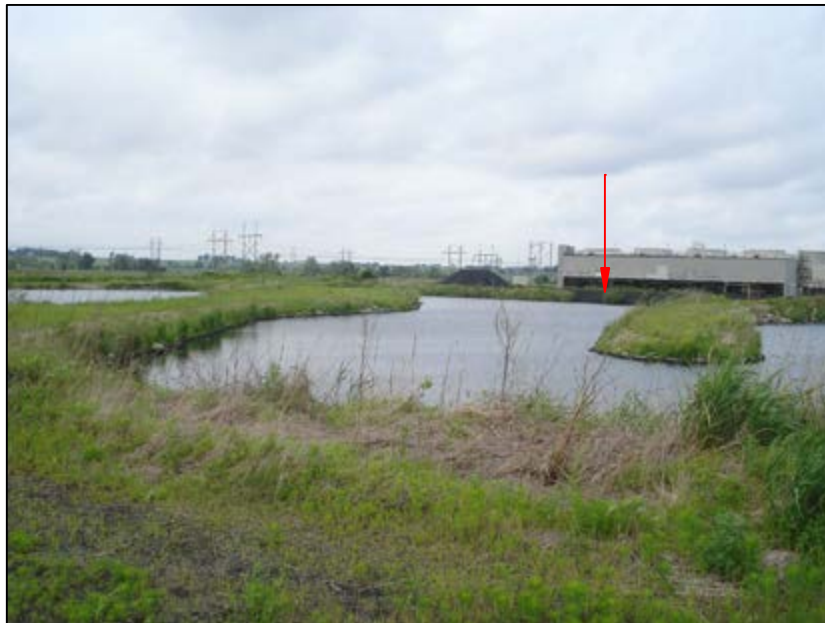
SECP-2

LOOKING SOUTHWEST AT INTERIOR OF SECONDARY POND. STEEP AND BARE SLOPE AREA AT SOUTH POND INLET IN BACKGROUND

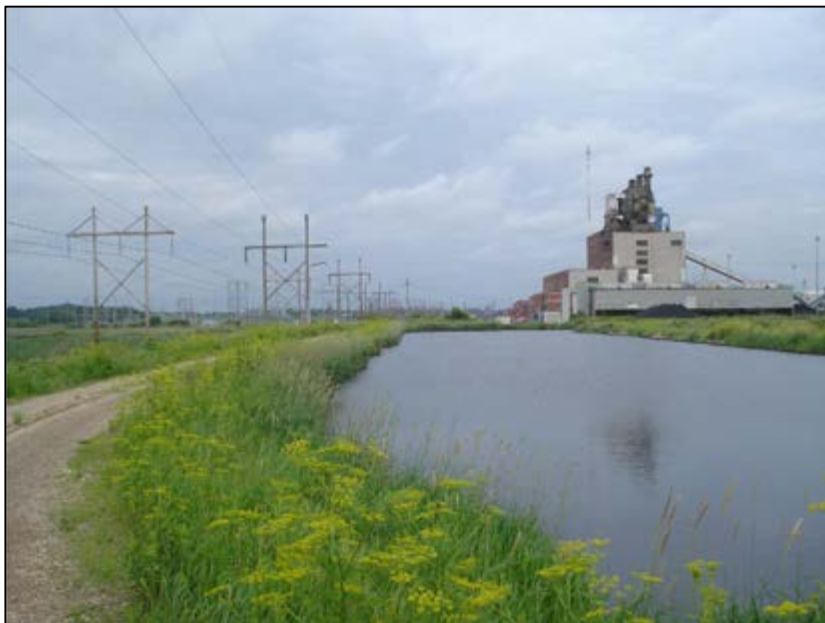
SECP-4

LOOKING WEST AT US SLOPES OF SOUTH DIKE OF SECONDARY POND. TALL VEGETATION, SLOUGHS OBSERVED ON US SLOPE

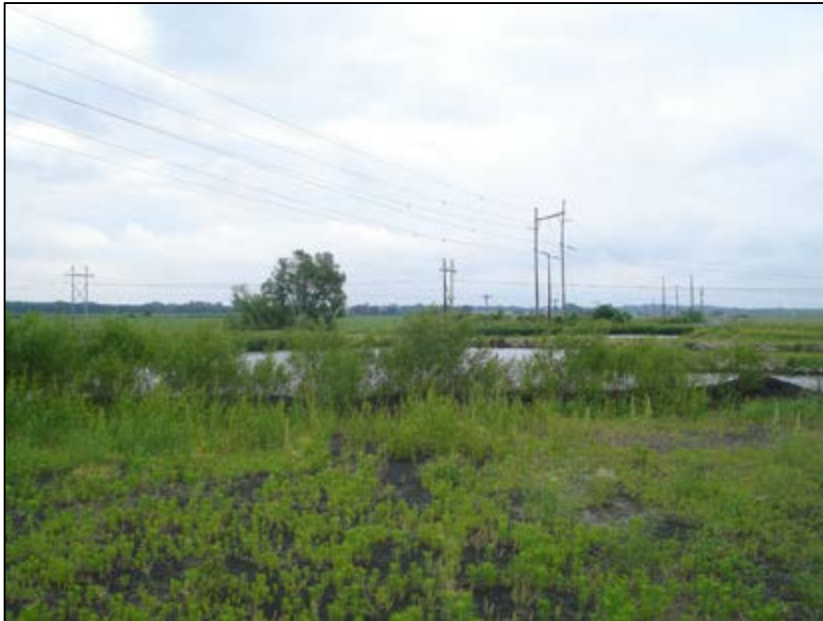
SECP-8

LOOKING SOUTHEAST AT INTERIOR OF SECONDARY POND

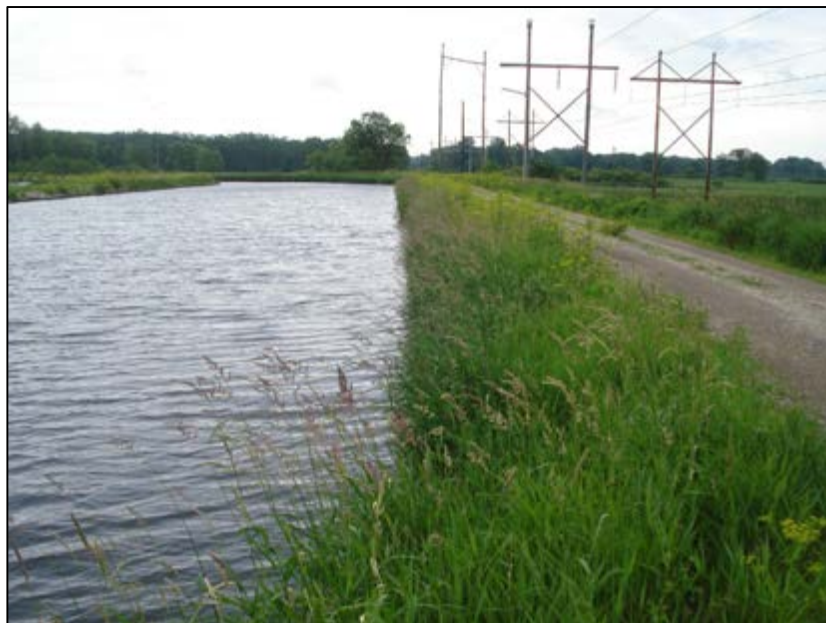
SECP-14

**LOOKING EAST AT US SLOPES OF SECONDARY POND,
TALL VEGETATION AND ISOLATED ERODED AREAS**

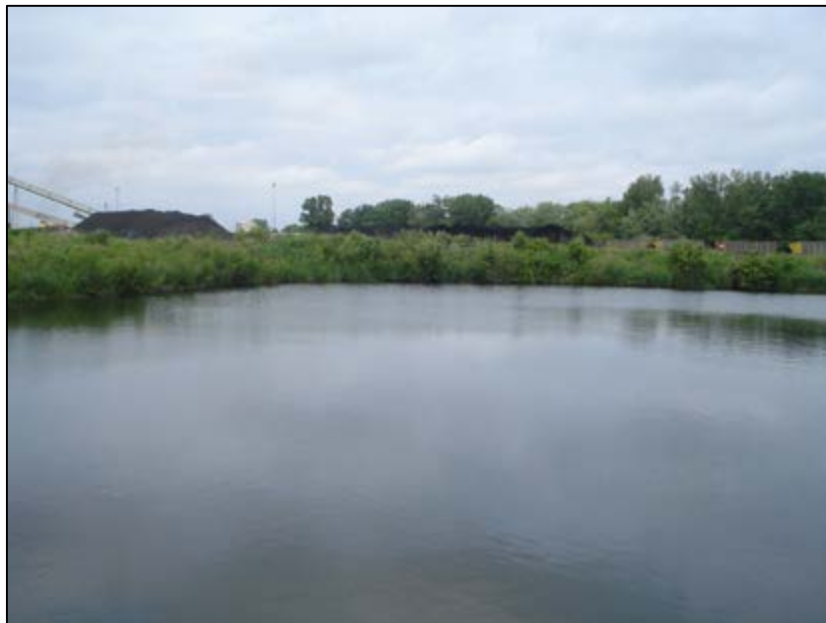
PP-2

**LOOKING NORTHWEST ACROSS POLISHING POND,
STEEP SLOPES, TALL AND SOME BRUSHY VEGETATION**

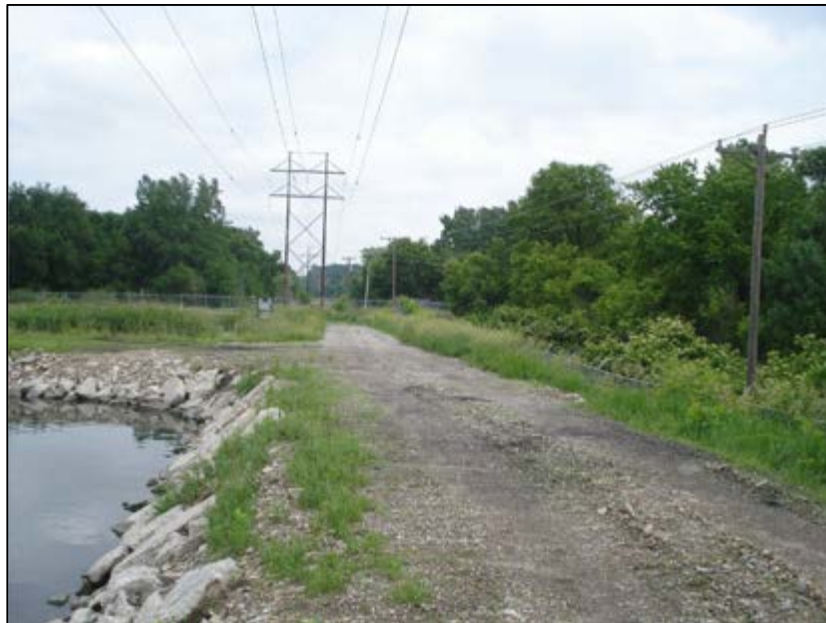
PP-4

east embankment. This indicates a recent repair and the slopes are in good condition (Photo PP-4). The upstream slopes on the north half of the east embankment were covered with tall grass which prevented observation of the surface of the slopes. Although restricted by these conditions, the upstream slopes viewed from across the pond appeared to be steep and in fair condition (Photo PP-5). The downstream slopes on the east embankment were covered with tall grass which prevented observations of the surface of the slopes. Although restricted by these conditions, no evidence of surface sloughing or other failures were observed on the downstream slopes (Photos SECP-15 and SECP-21).

The area at the discharge pond was covered in tall grasses which prevented viewing of the upstream and downstream slopes (Photos DP-1 and PP-4). Although restricted by these conditions, no evidence of surface sloughing or other failures were observed on the slopes.

**LOOKING NORTH AT CREST AND US SLOPE OF EAST DIKE OF
POLISHING POND, RECENT REPAIR (RIP-RAP) ON EAST DIKE**

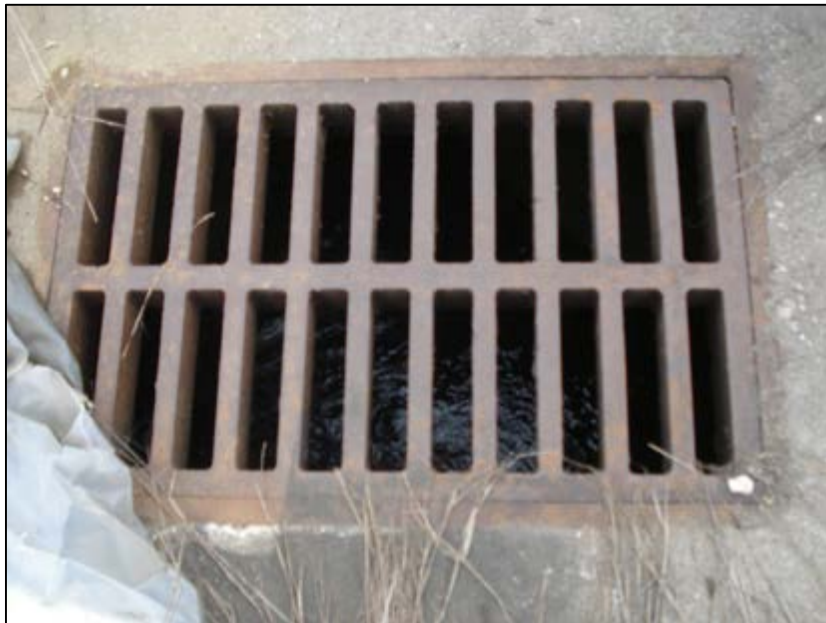
OP-2

SURFACE DRAINAGE CATCH BASIN AND MANHOLE FOR POND OUTLET
DITCH ON WEST SIDE OF PLANT PROPERTY

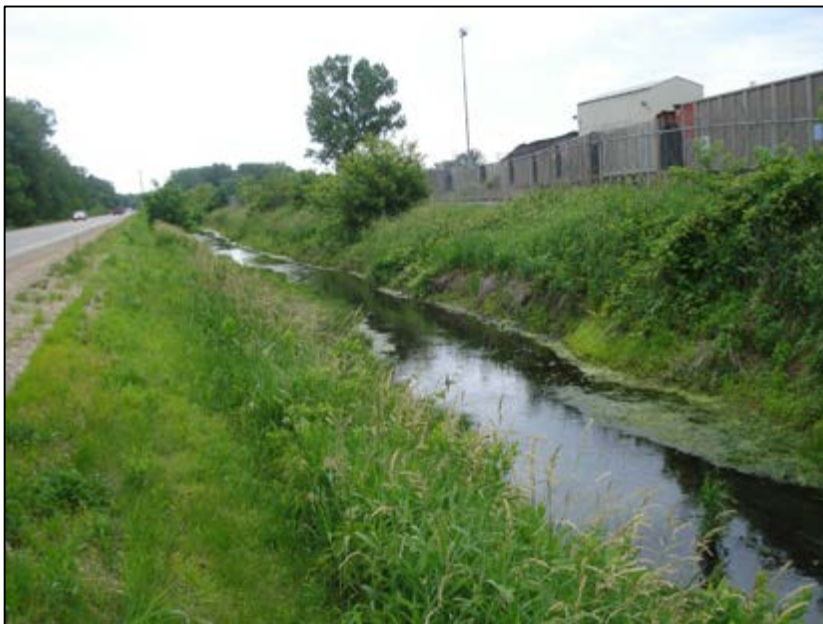
OP-4

LOOKING EAST AND DOWNSTREAM OF ROADSIDE DITCH
